ST. PAULS SCHOOL DAM

NH 00361

PHASE I INSPECTION REPORT NATIONAL DAM INSPECTION PROGRAM

MARCH 1980

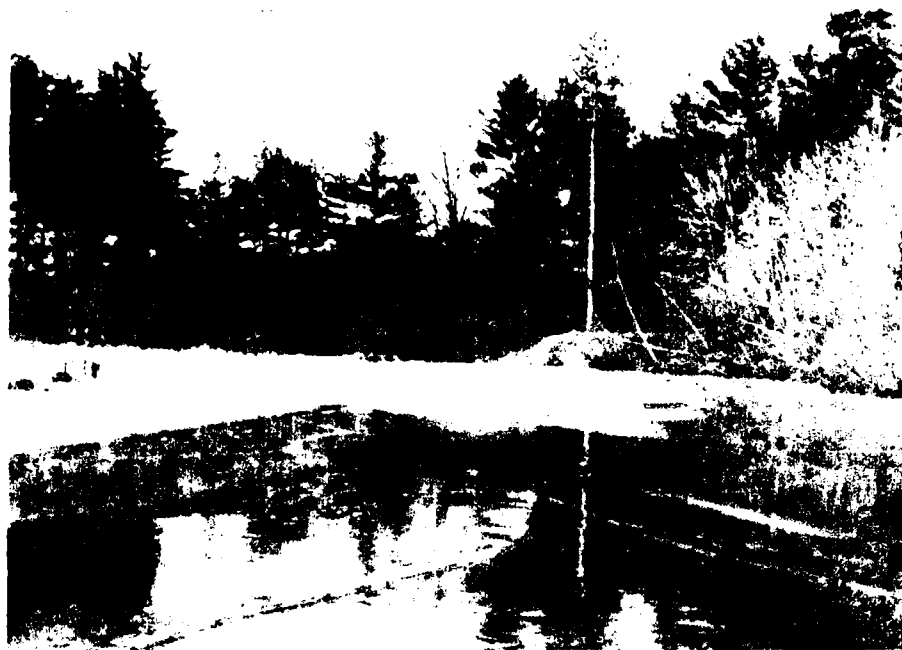
d. Reservoir Area. The slopes of the reservoir appear to be stable. No evidence of significant sedimentation was observed. The approach channel to the dam is unobstructed. (See Photo No. 1.)

Photo No. 1 - General view of pond from dam.

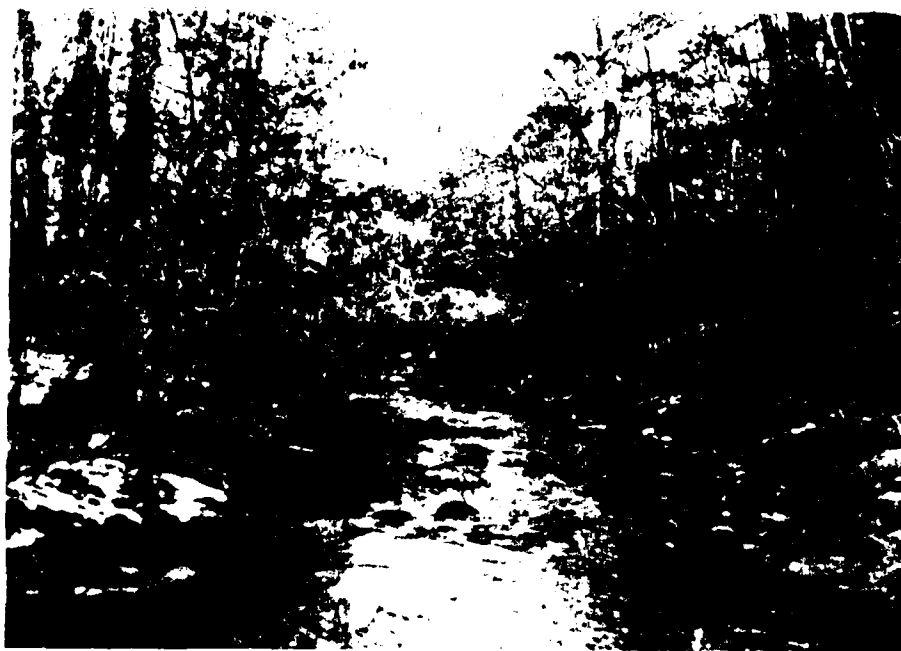
Photo No. 9 - View of downstream channel approximately 100 feet below dam.

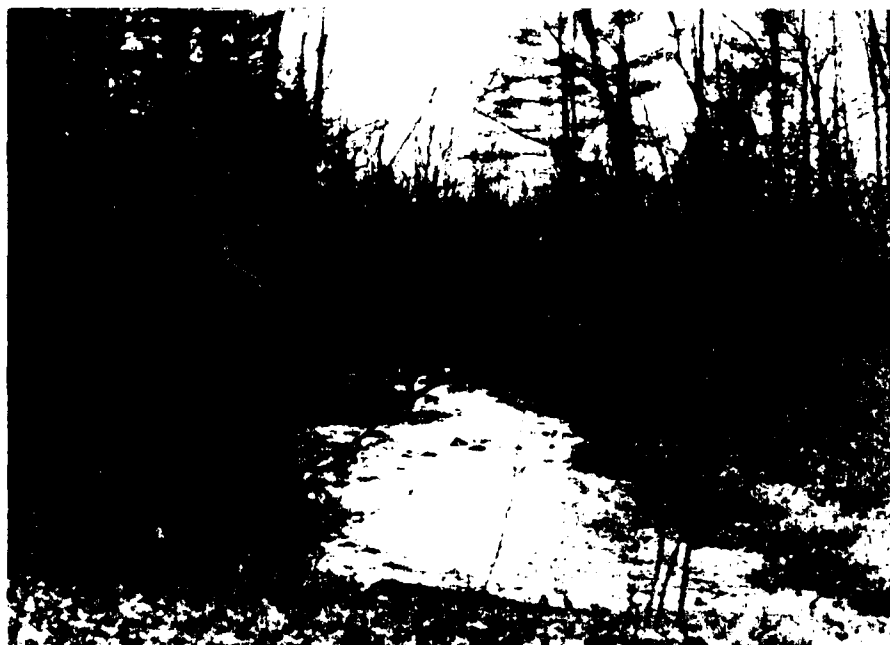
Photo No. 10 - View looking upstream from bridge approximately 1,000 feet below dam.

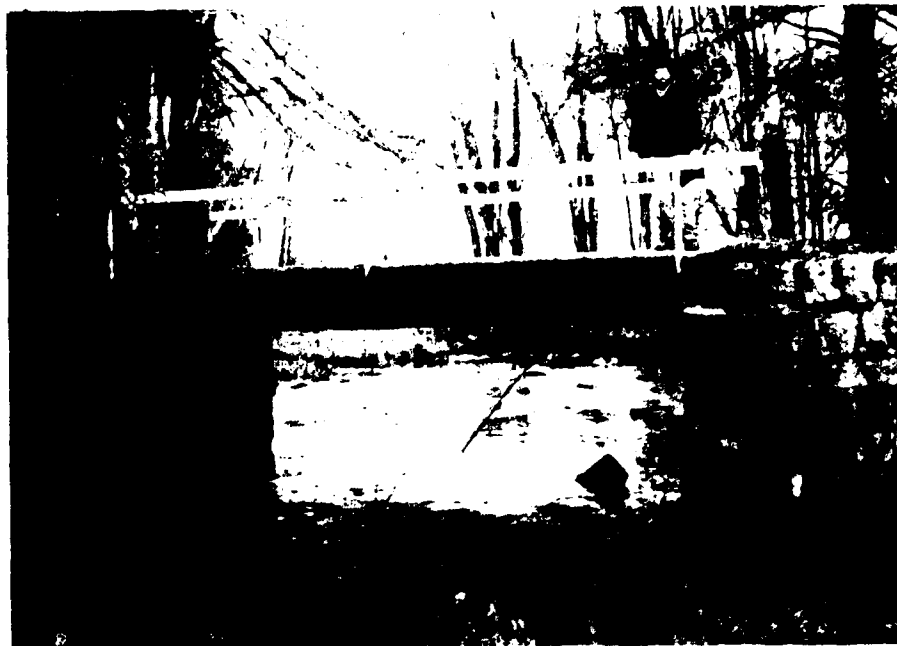
Photo No. 11 - View of upstream face of bridge.
